## EFFLORESCENCE, LIME STAINING AND GOOD SITE PRACTICE

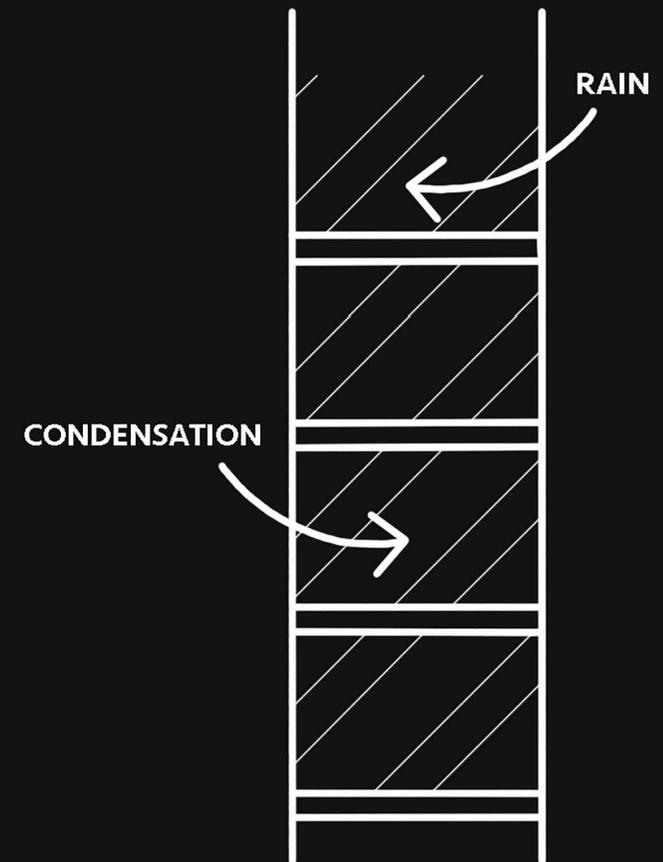
□ Weep holes need to be clear of debris which will collect during and after completion. Cavity trays need to be clear of droppings. If droppings have accumulated, bricks may have to be removed locally to gain access to the cavity.

□ Mortar must be kept clear from the inside cavity which could otherwise deflect water into the brickwork. Internal snots and mortar which has not been cleaned is unacceptable and may lead to efflorescence. Mortar droppings on wall ties can also cause water to run on the rear of the brick skin.

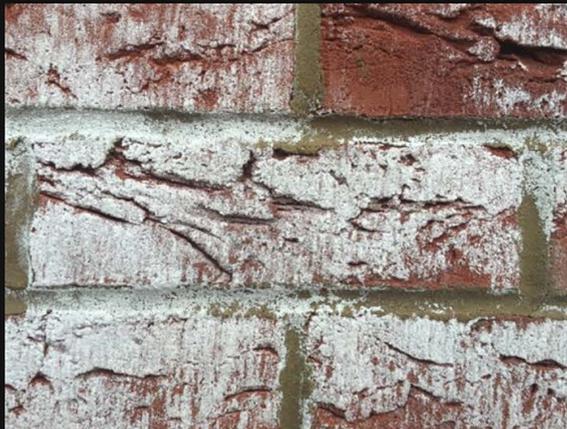
- Fired clay may contain soluble salts.
- Brickwork when saturated dissolves salts.
- When the brick dries the moisture moves to the surface.
- The moisture evaporates leaving the salts as efflorescence.

The solutions are different; efflorescence should be allowed to weather away naturally and no spraying is advised. The salts may be brushed away with a bristle brush and taken away from the wall. High pressure washing will make the issue worse as when the bricks dry, more salts are drawn out and redeposited.

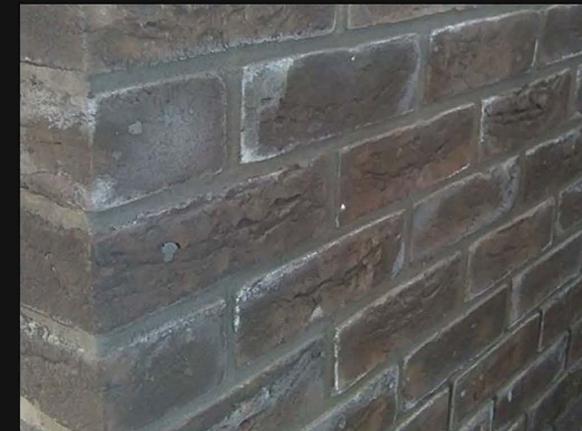
- The wall is unprotected and becomes saturated.
- Free lime released by the mortar seeps out of the joints.
- Calcium hydroxide is formed on the surface turning into Calcium Carbonate or Limestone which is impervious to water.

Lime staining is the deposit of calcium carbonate by reacting to the atmosphere on to the face of the brickwork. Lime staining can be distinguished by the flat top to the staining stemming from the bedjoint, or alternatively fanning out from the cross joint, clearly associated with the horizontal or vertical joints.
